June 2024 Midwest Storm and Flooding

USDA NASS Disaster Monitoring Team

Event Summary

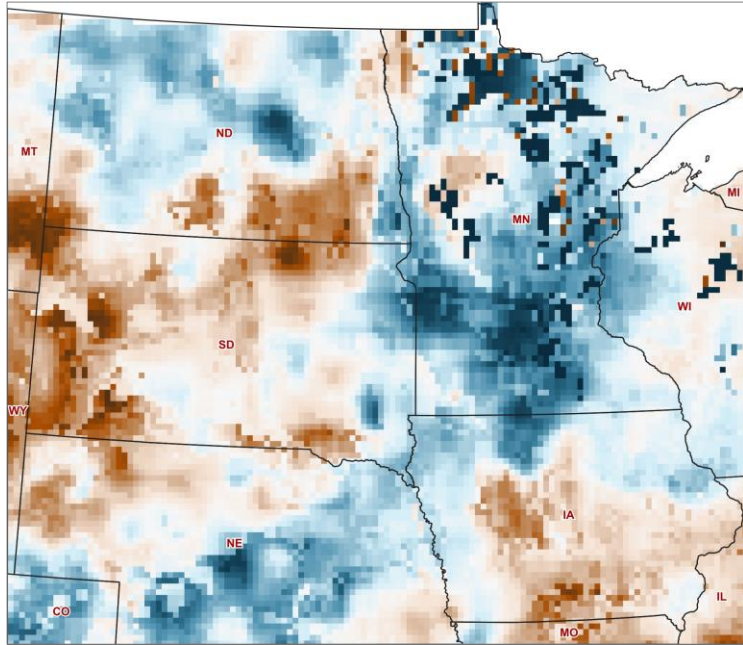
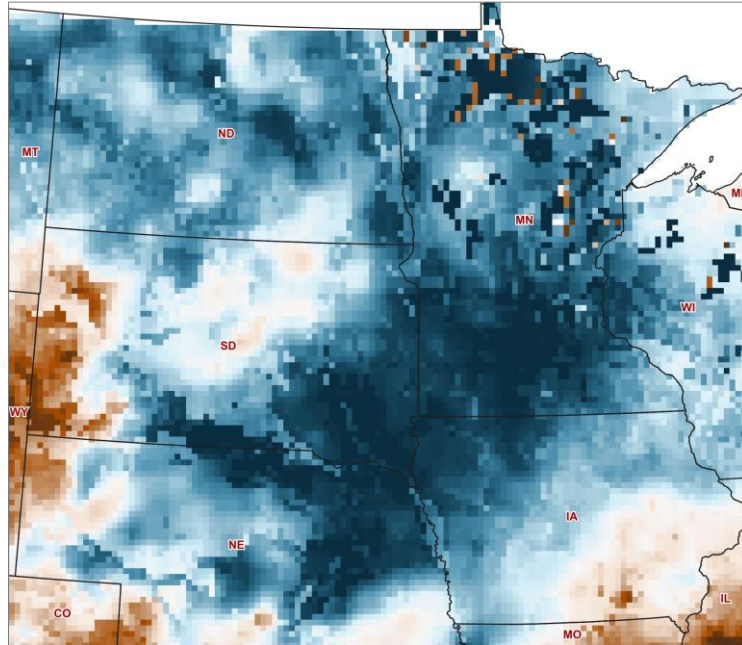
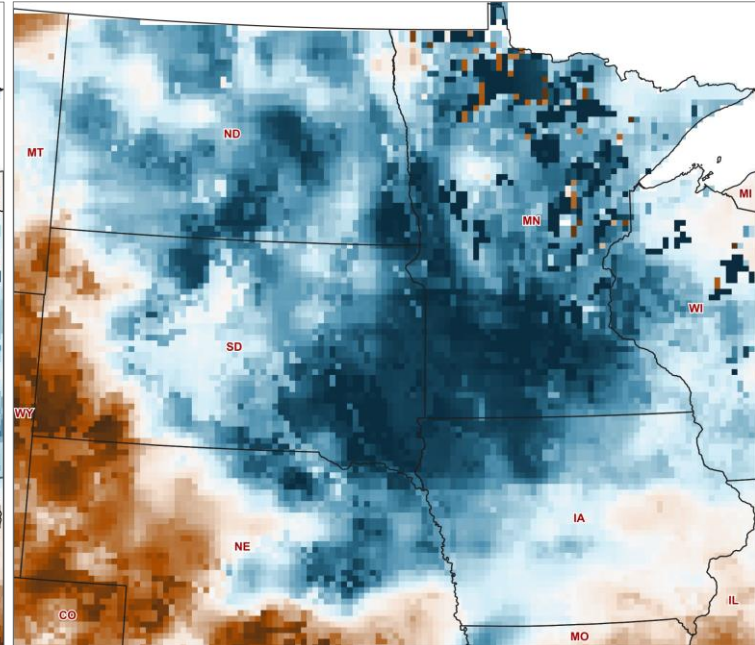
June 10 – 16, 2024:
SMAP 9 KM Anomaly Weekly Topsoil

June 17 – 23, 2024:
SMAP 9 KM Anomaly Weekly Topsoil

June 24 – 30, 2024:
SMAP 9 KM Anomaly Weekly Topsoil

Note: The soil moisture anomaly (SMA) in CropCASMA is a measure of deviation of the current soil moisture value from the "normal" soil moisture level, which is represented by a historical average soil moisture value (from 2015 to current).

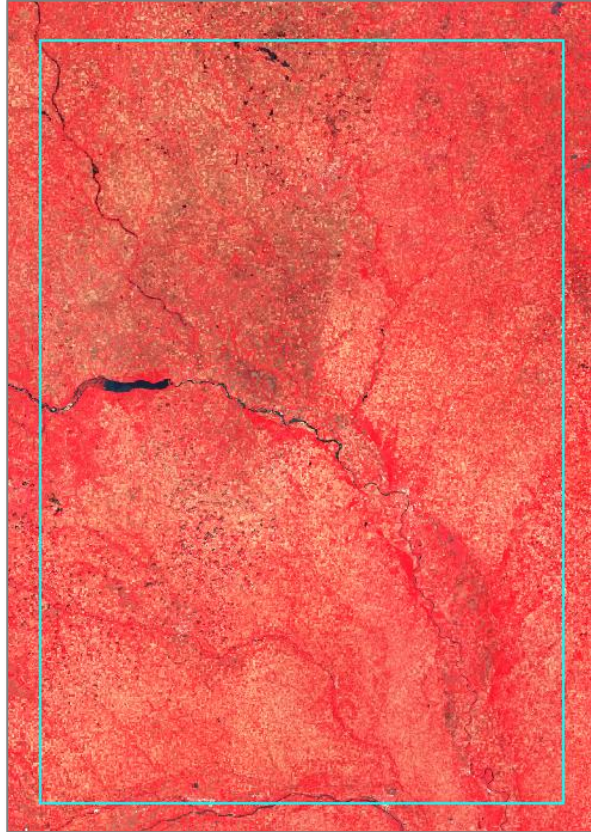
Pre-Event: Sentinel-2 MSI Median
Composite Image (June 1 – July 2, 2023)

The Sentinel-2 [Multispectral Instrument \(MSI\)](#) is a wide-swath, high-resolution, multi-spectral imaging sensor. Combination of its spectral bands enables a wide range of uses, including the monitoring of vegetation, soil, and water cover. The images above (left, middle) are displayed as False Color Infrared to assist in the identification of water and stressed vegetation (plant-covered land appears deep red, denser plant growth is darker red, and water appears blue or black).

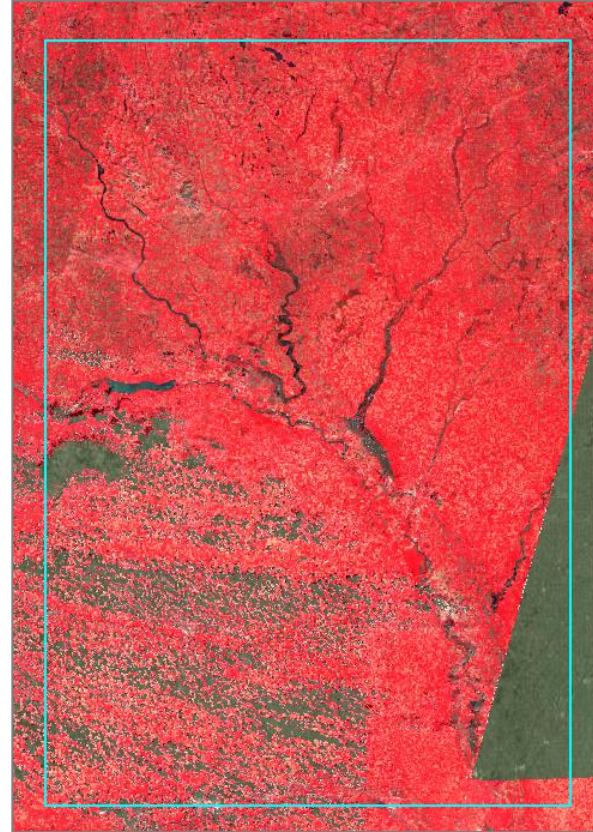
Post-Event: Sentinel-2 MSI Median
Composite Image (June 17 – June 30, 2024)

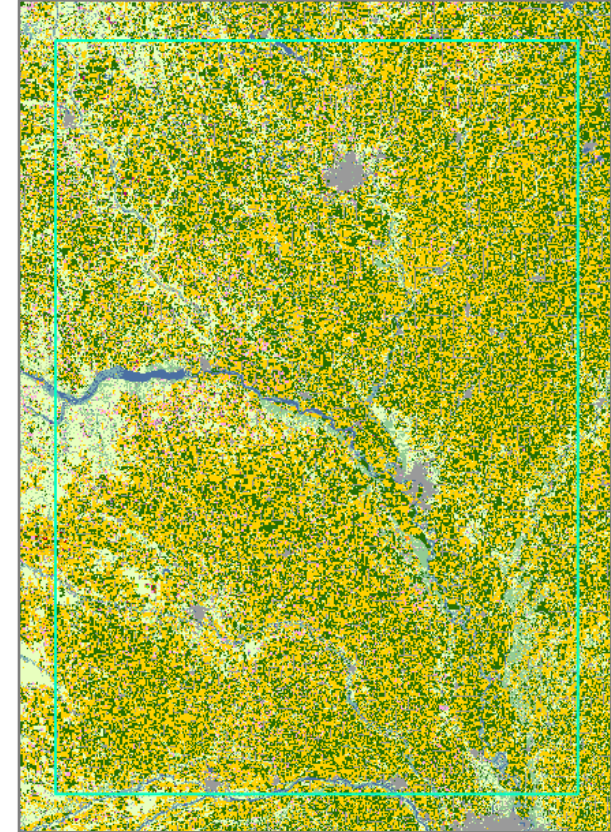
Agriculture:
USDA-NASS 2023 Cropland Data Layer

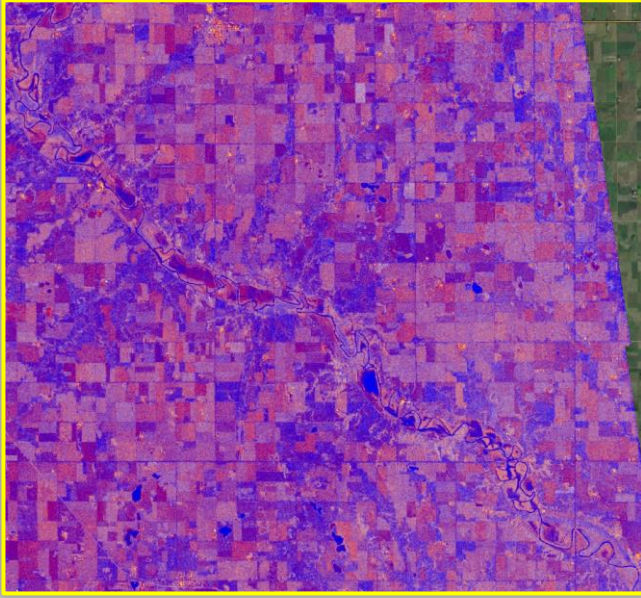
Pre-Event: Sentinel-1 SAR Median Image Composite (June 1 and July 3, 2023)

[SENTINEL-1 Synthetic Aperture Radar \(SAR\)](#) is an imaging radar mission providing continuous all-weather, day-and-night imagery at C-band. It is used for maritime monitoring, land monitoring, and emergency management applications (to include flood area detection).

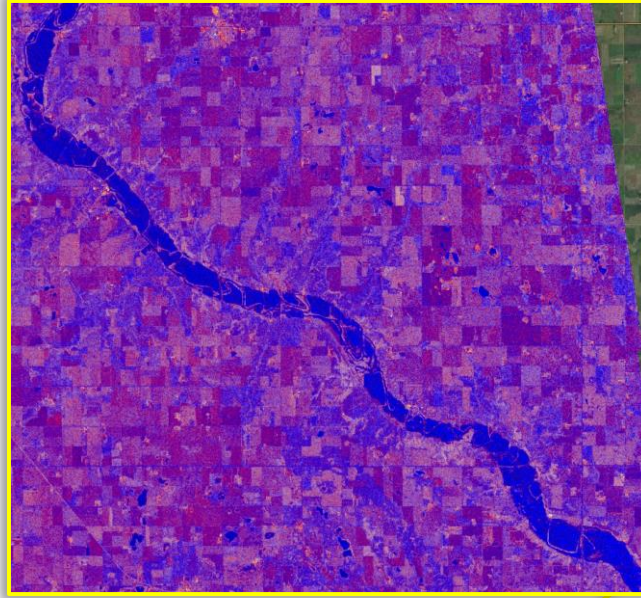
Post-Event: Sentinel-1 SAR Image (June 17, 2024)

The example above depicts likely inundation in the blue areas within the post-event image displayed above to the right.

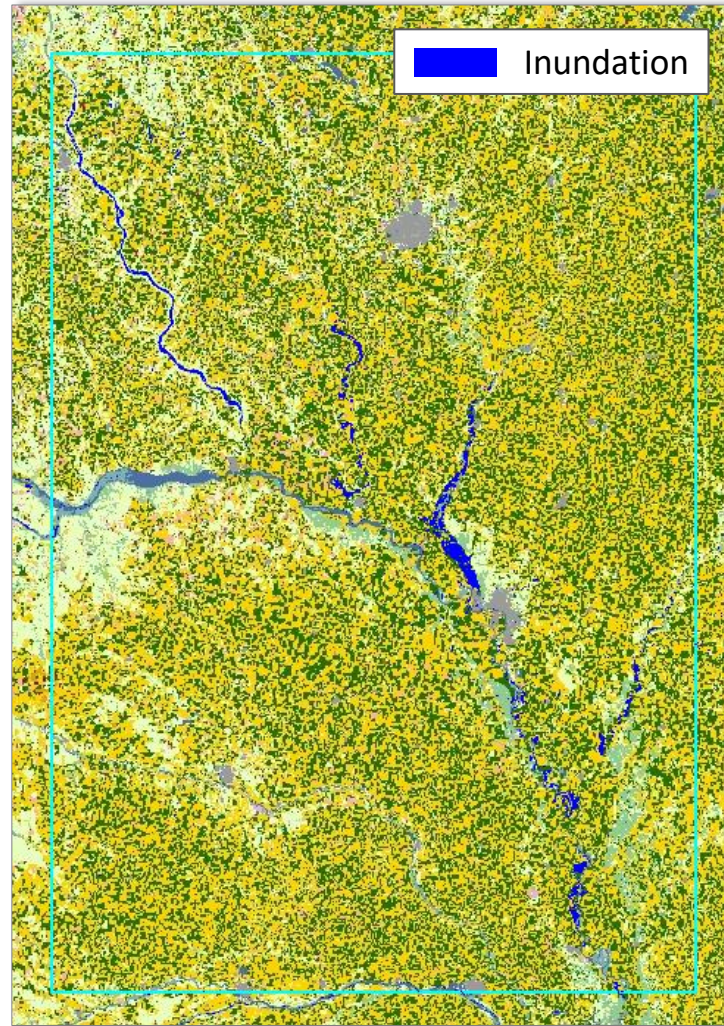
The above areas displayed in blue in the geographic reference map (left) and overlaid on the CDL (middle) are areas assessed as inundated within the overall study area for this disaster assessment. Acreage affected per crop type within the study area are listed in the table above (right). Noted: **Estimated acreage reported above is approximate and based on analysis using the 2023 CDL.**

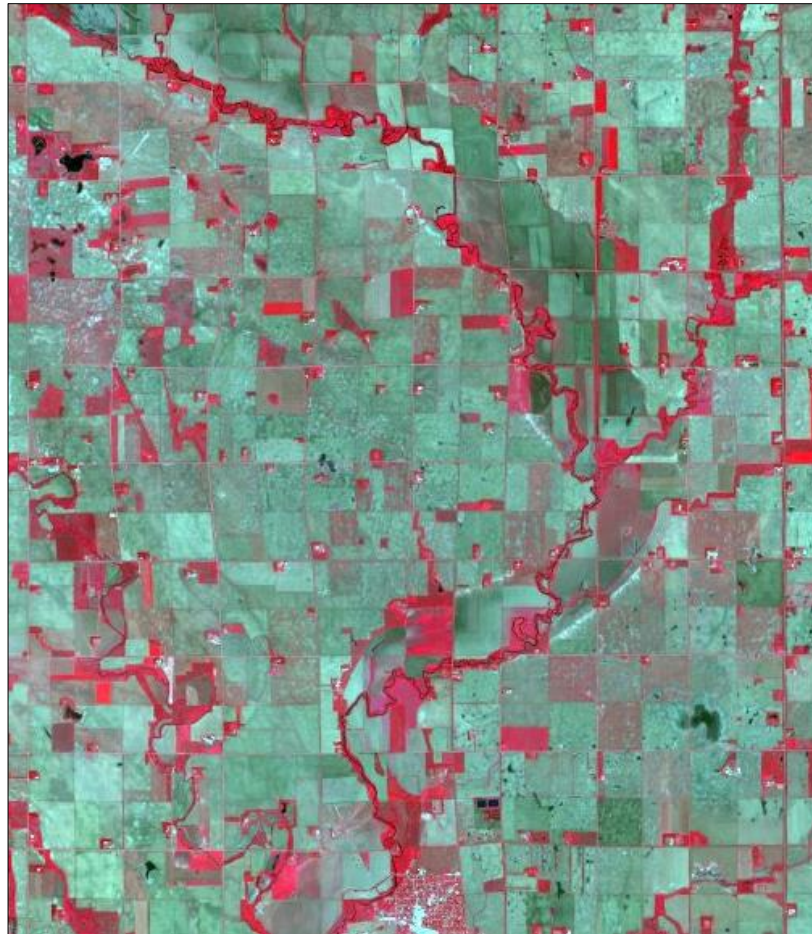
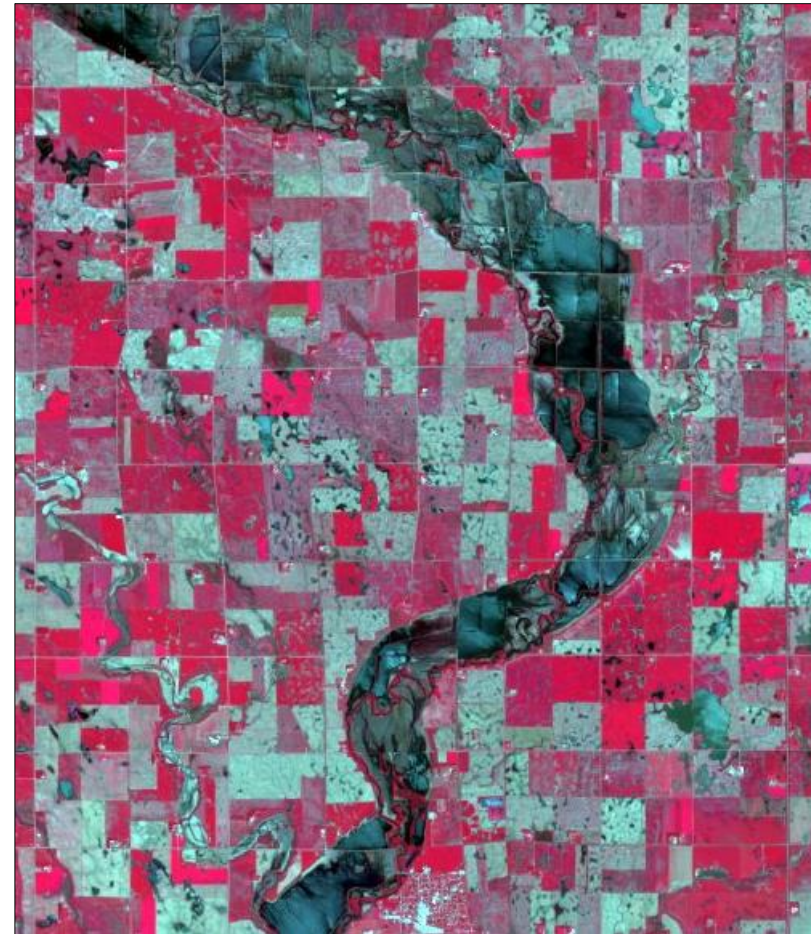
Pre-Event: Sentinel-2 Color Infrared
(June 10, 2024)

Post-Event: Sentinel-2
Color Infrared (June 30, 2024)

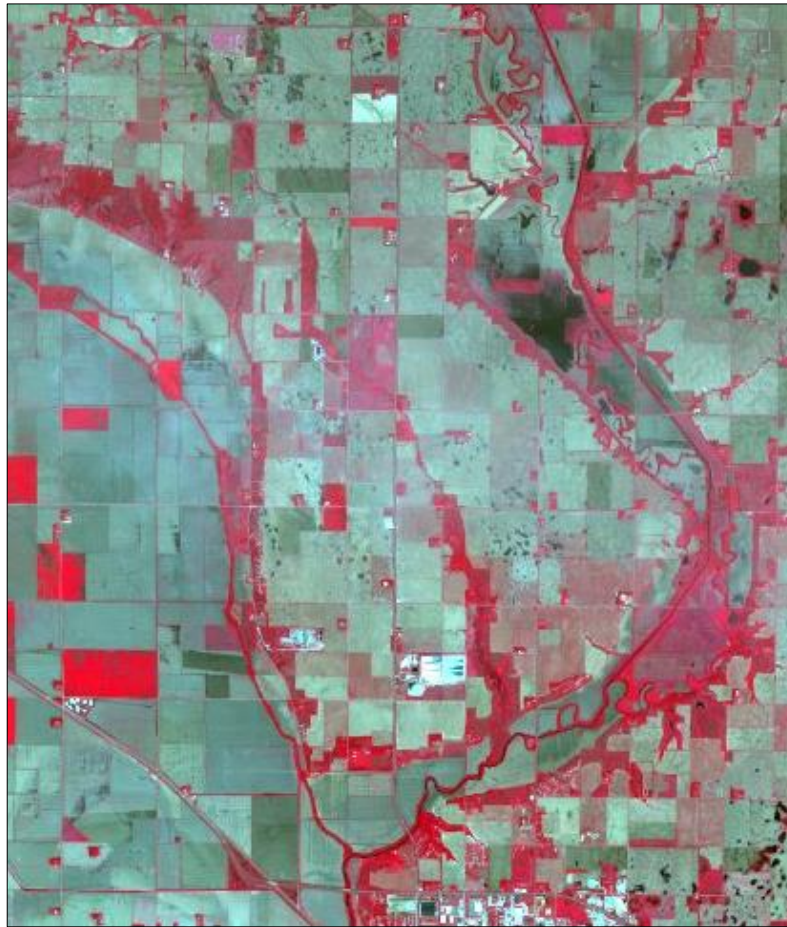
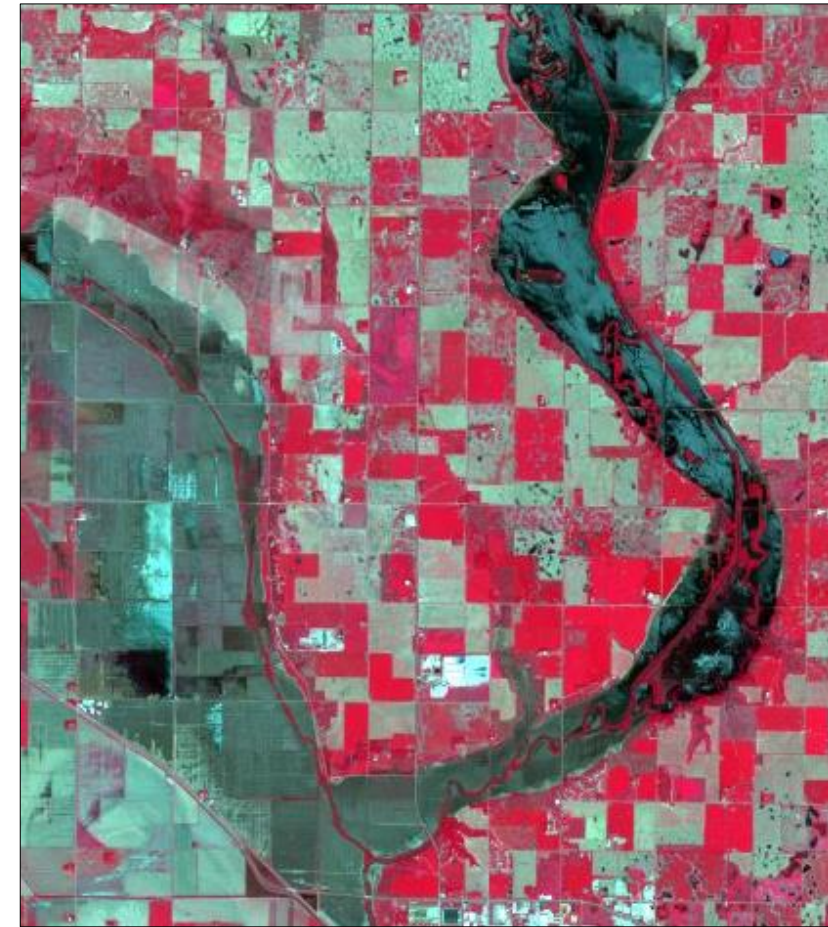
Pre-Event: Sentinel-2 Color Infrared
(June 10, 2024)

Post-Event: Sentinel-2
Color Infrared (June 30, 2024)

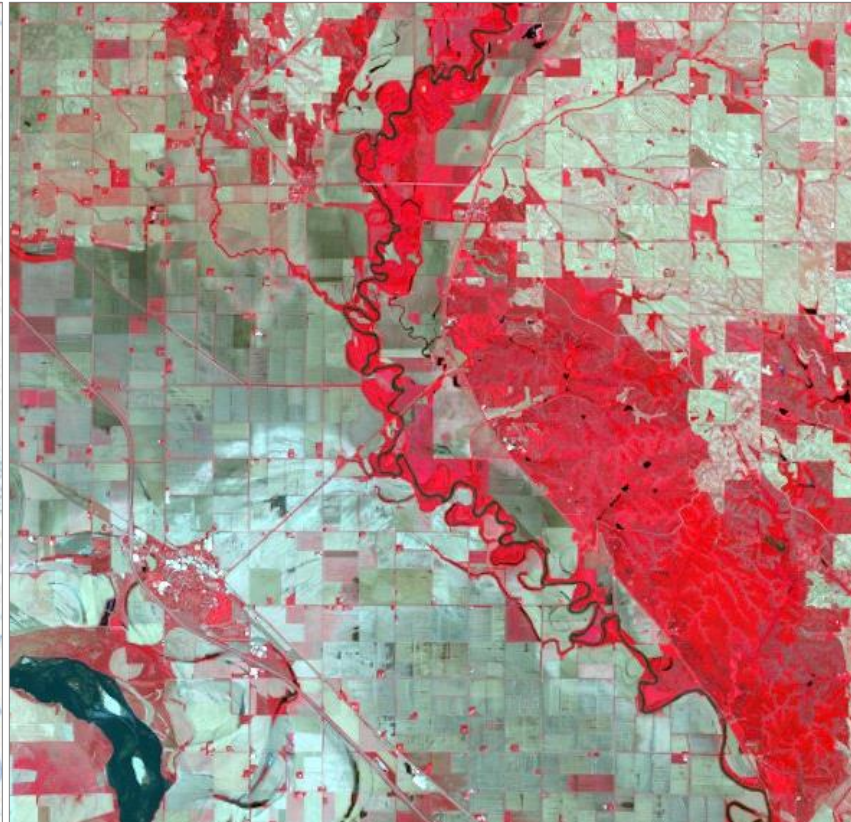
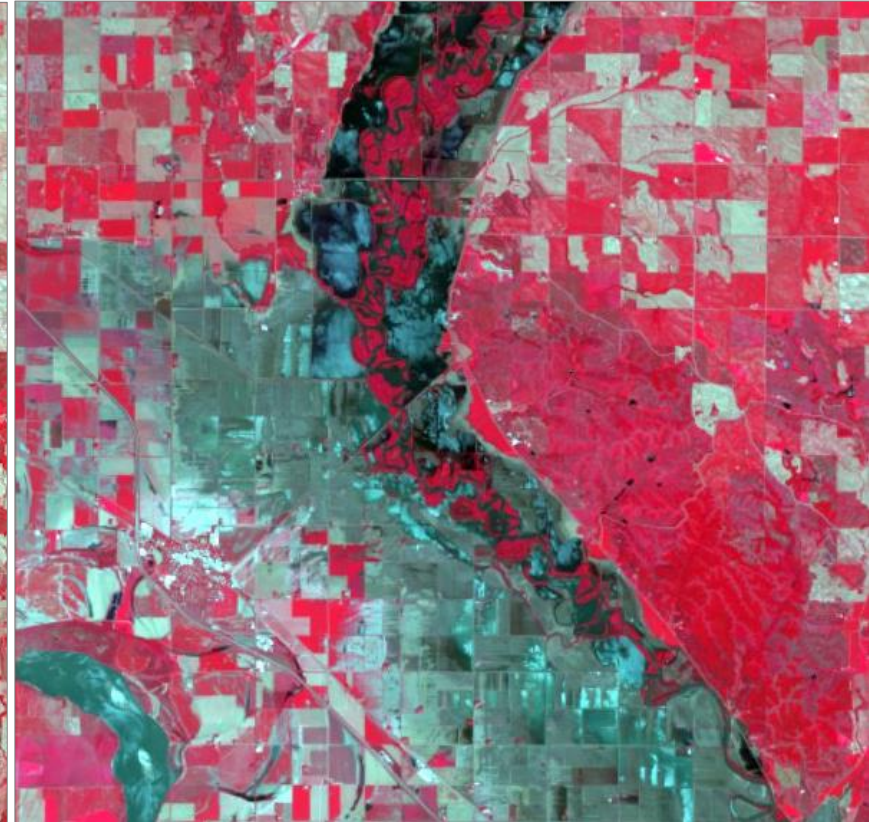
Pre-Event: Sentinel-2 Color Infrared
(June 10, 2024)

Post-Event: Sentinel-2 Color Infrared
(June 30, 2024)

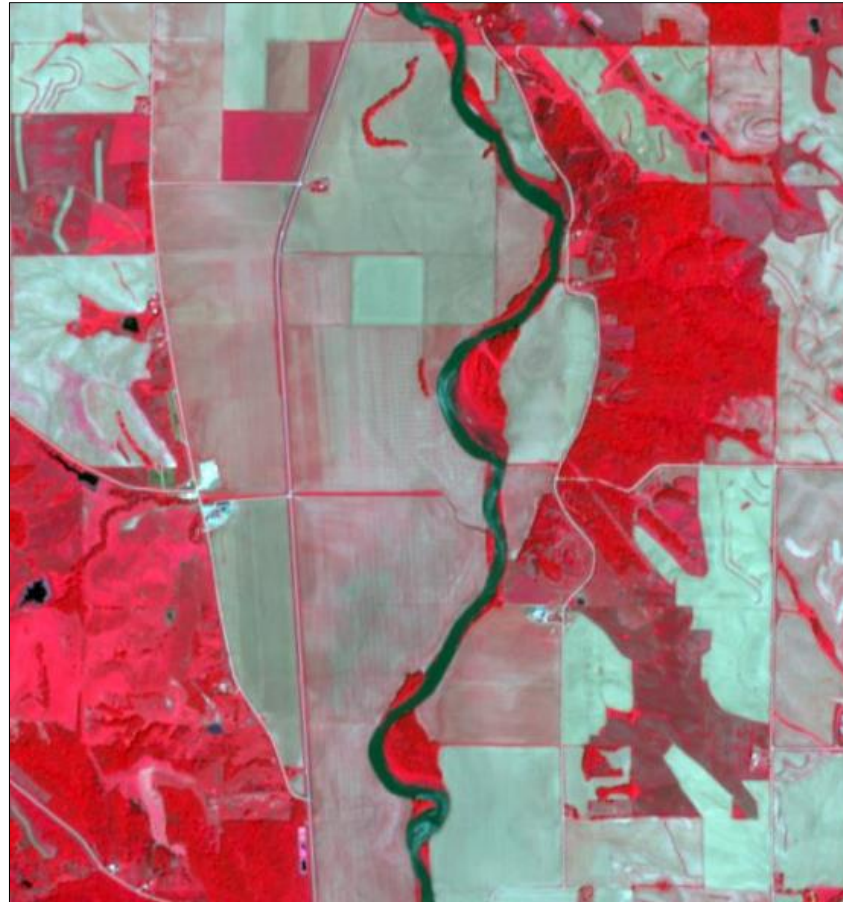
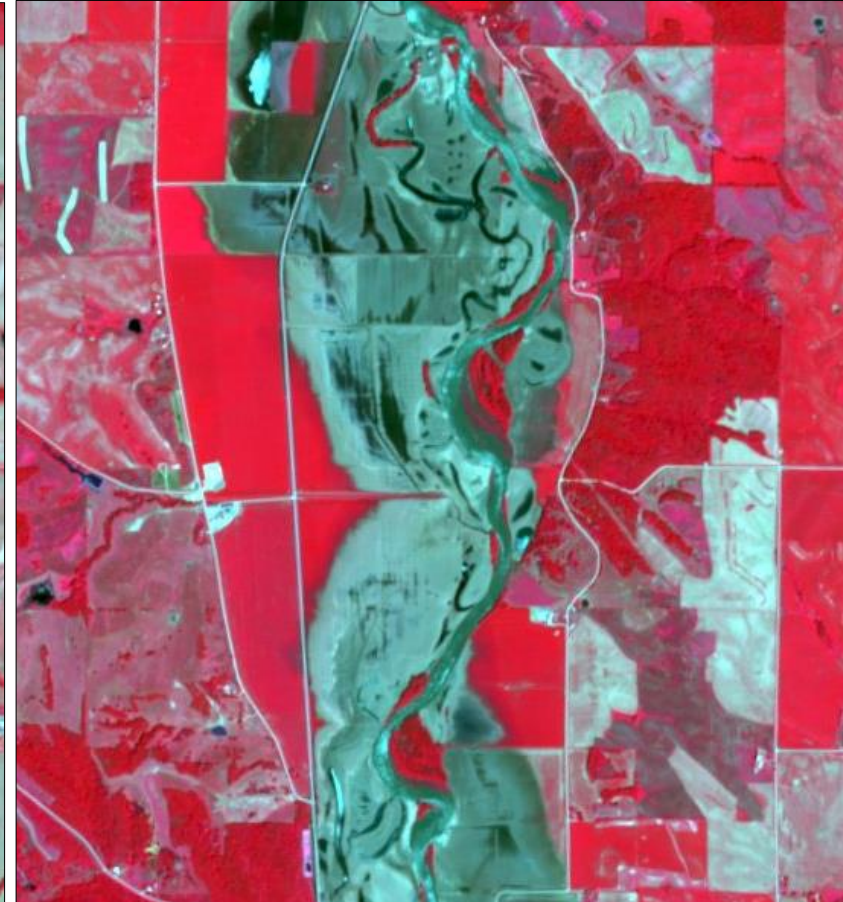
Pre-Event: Sentinel-2 Color Infrared
(June 10, 2024)

Post-Event: Sentinel-2 Color Infrared
(June 30, 2024)

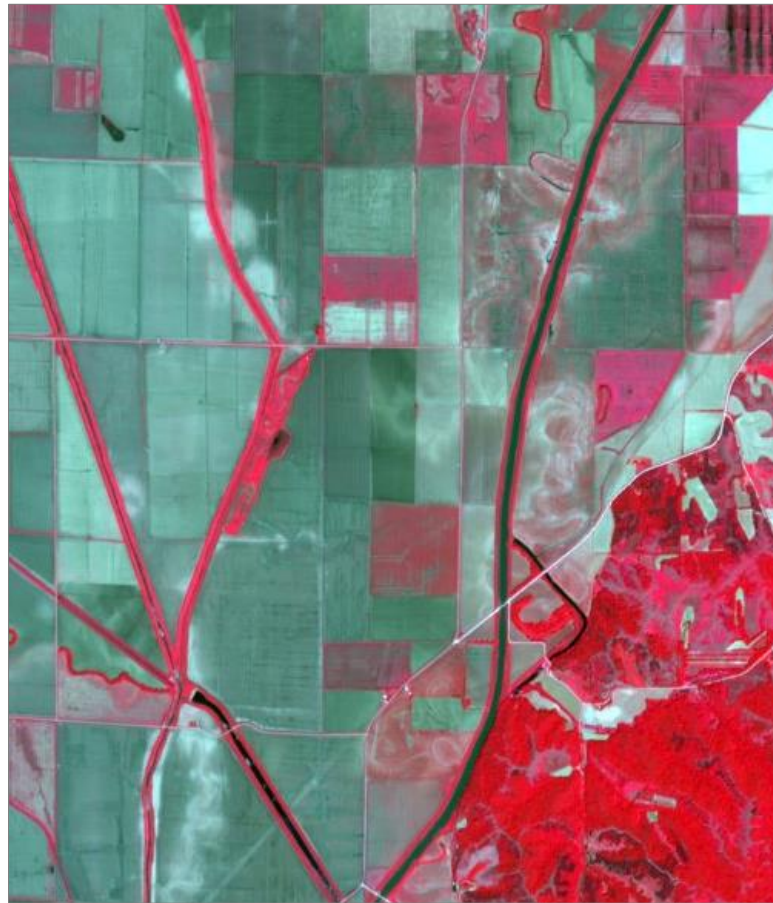
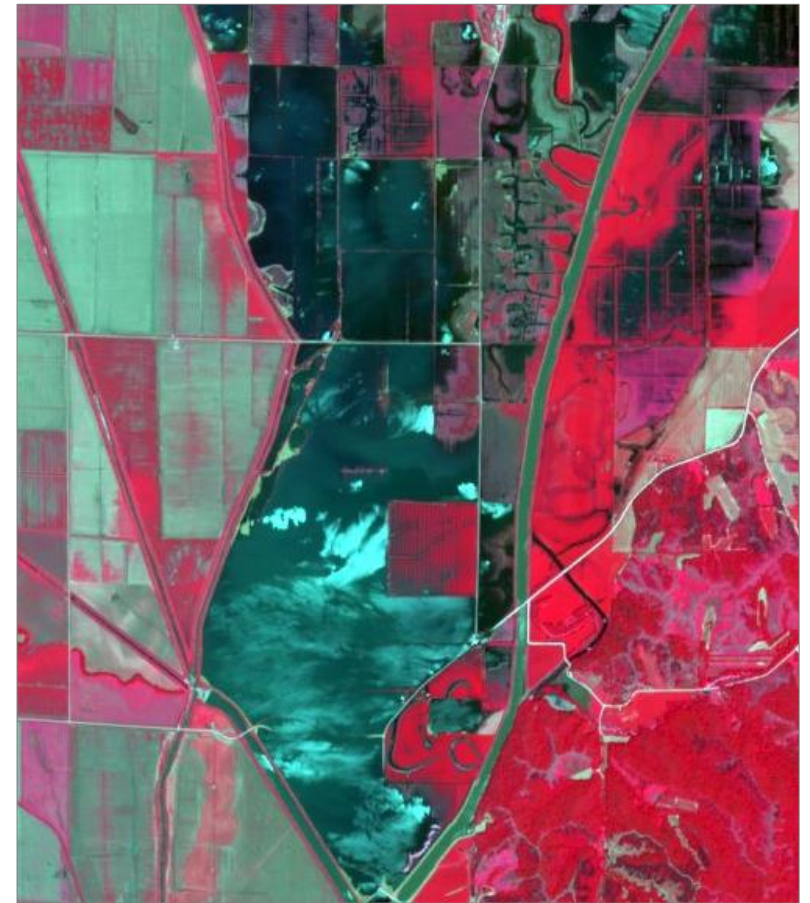
Pre-Event: Sentinel-2 Color Infrared
(June 10, 2024)

Post-Event: Sentinel-2
Color Infrared (June 30, 2024)
